Window Leaks Caused By Lintel Deterioration

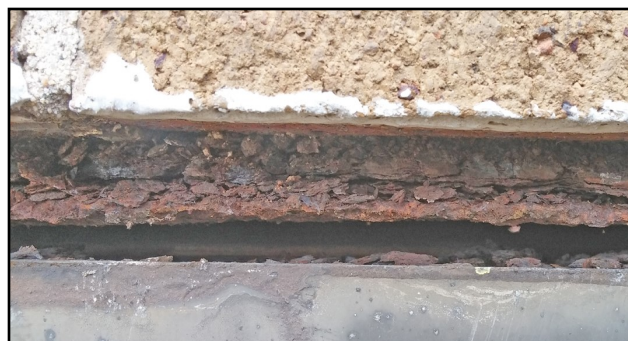
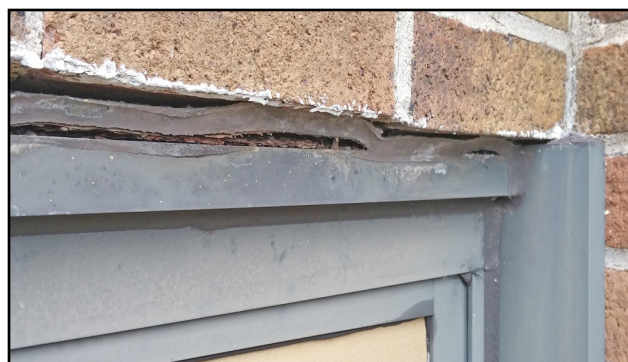
Lintels, like bricks, are tremendously tough, but not indestructible. Factors like cracks in the exterior masonry, humid climate, heavy precipitation and the freezing and thawing of cold Ohio winters weaken lintels and surrounding masonry. This allows moisture to leach inside, deteriorating the lintels, causing rust to occur in the form of severe oxidation. If left untreated, the rust build-up causes the lintel to expand and lose strength, creating added pressure against the surrounding masonry.

Often times during and after a rainstorm, lintel deterioration is mistaken for leaking windows and doors when water seeps into the building from above the opening. The cause of the water leak may not have anything to do with the window or door. Should this condition occur, a building's facility manager should first thoroughly check the exterior of the building for signs of lintel decay.
